Manhole Inspection Summary

Manhole # S41A__004MH

Insp Date: **6/26/08 10:15 AM**

Location Address: **500 n caroline st**

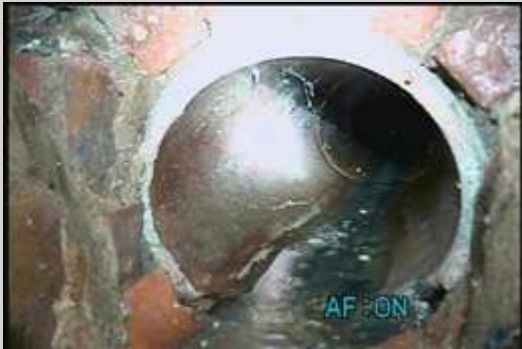
12 O'Clock Outflow

8 in. Circular Gravity Sewer
Pipe Out @ 12 O'Clock

Pipe Material: **Clay** ☐ Pipe Lined

Invert Depth: 11.03 (ft.) Flow Characteristics: **Slow**

Infiltration: **None**

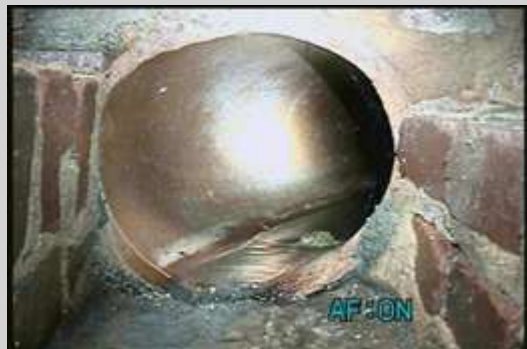
6 O'Clock Inflow

8 in. Circular Gravity Sewer
Pipe In @ 6 O'Clock

Pipe Material: **Clay** ☐ Pipe Lined

Infiltration: **None** Pipe Seal Cond: **Unknown**
